Reduction of the Negative Differential Pressure by Using a Piccolo-type Igniter to the 40mm KE Ammunition

Agency for Defense Development, Korea

40mm APFSDS-T Ammunition

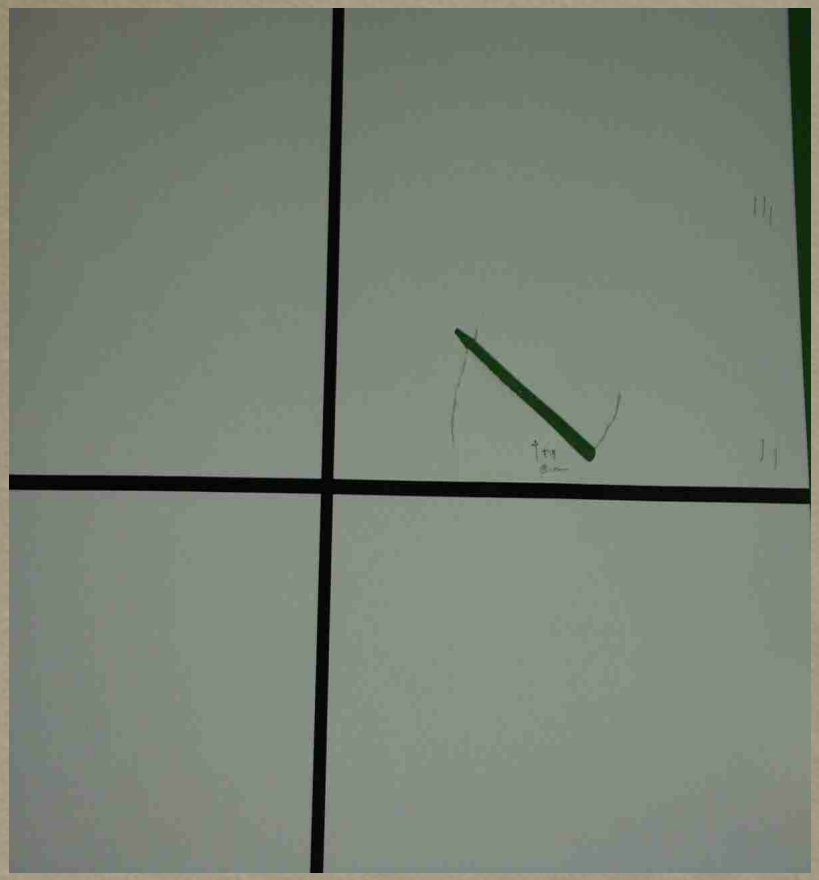
The projectile fracture experienced(3/6)

- Footprints in yaw cards
  - **@ 20m fr. Muzzle**
  - **Broken penetrator**
  - **Fin Missing**

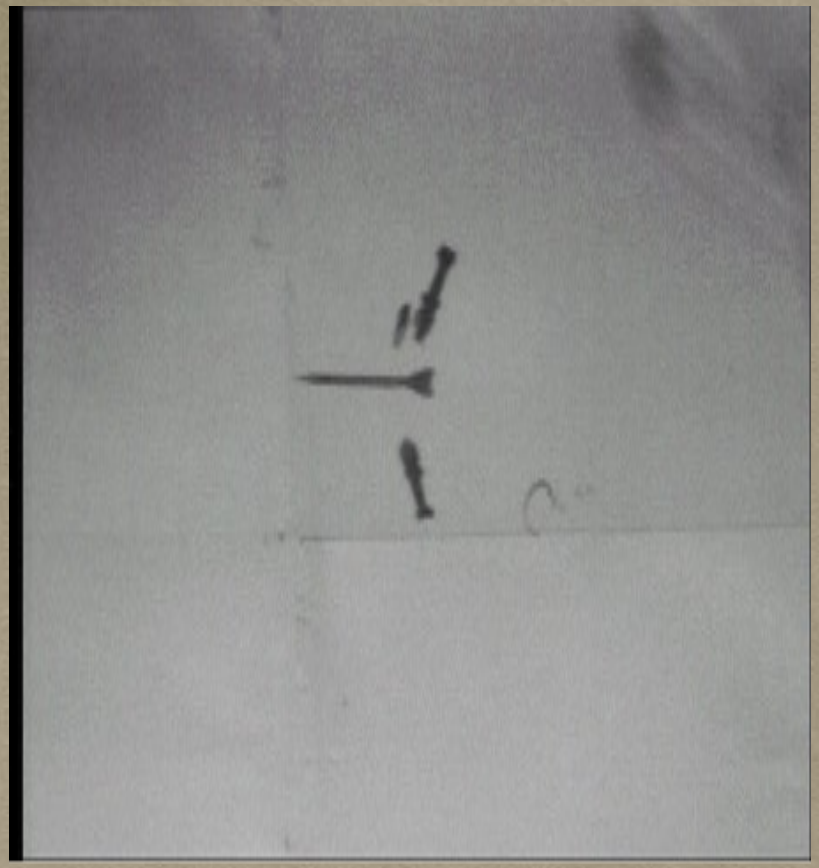
The projectile fracture experienced(6/6)

- Still video records
  - **Normal projectile**
  - **@ 7m fr. Muzzle**
  - **Penetrator/fin + sabot(3 pieces)**

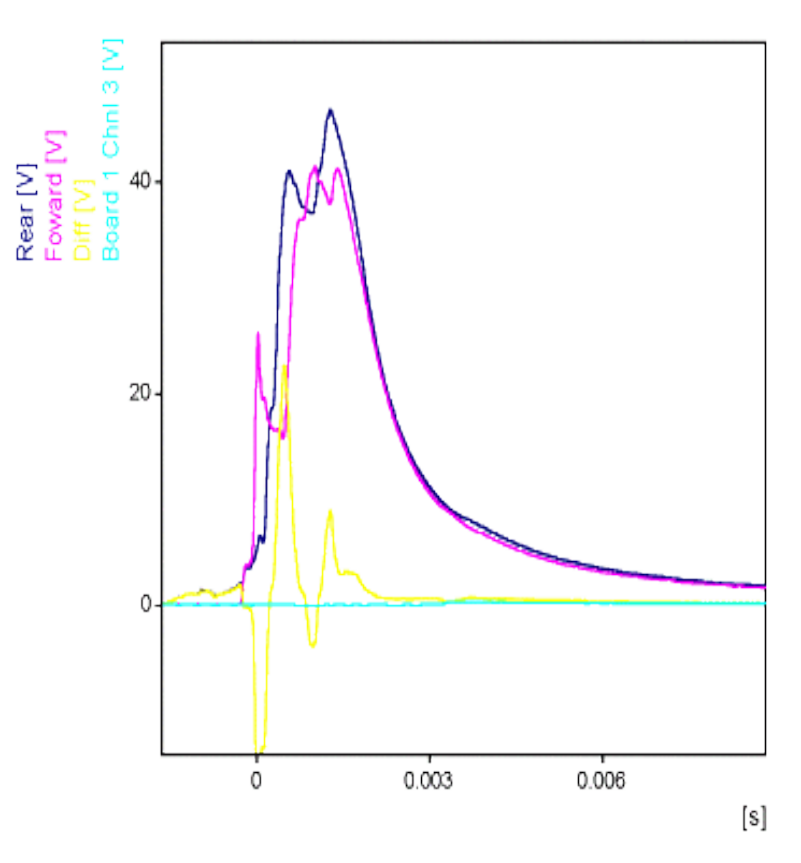
Negative differential pressure

- NDP
  - **Gage locations**
    -Rear:@ 90mm
    -Fwd:@ 280mm
    from RFT
  - **P_{max} ≈ 65,000 psi**
  - **-Δp ≈ 25,000 psi**
- Abnormal burning

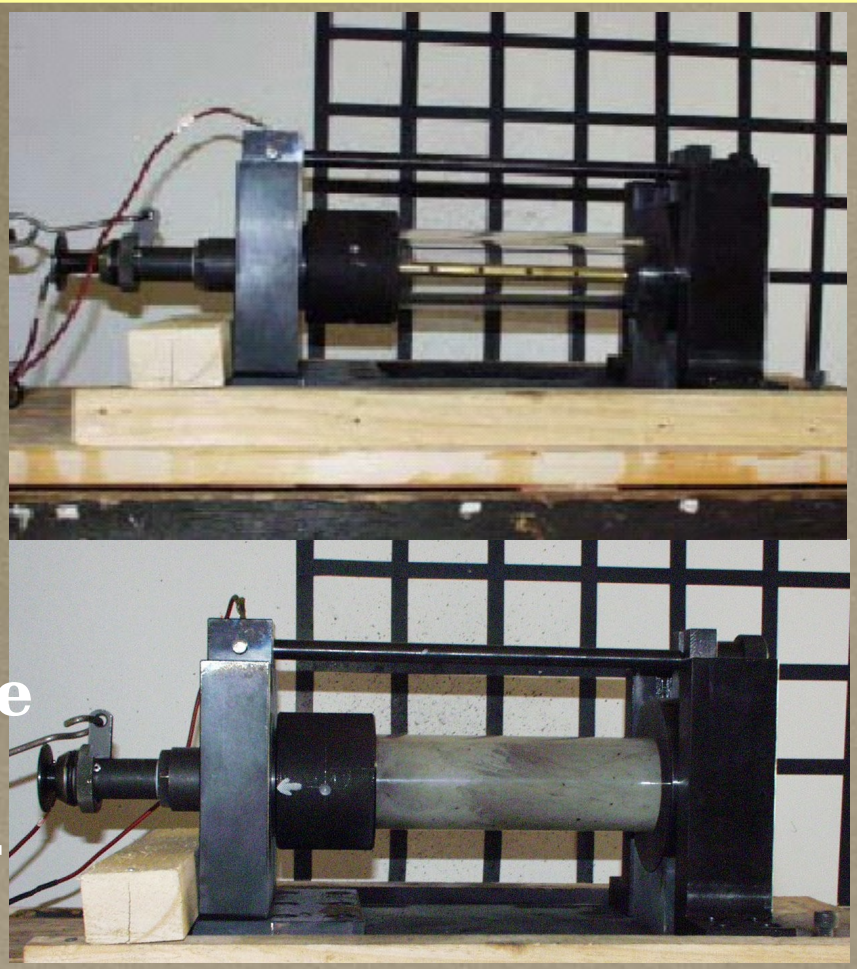
The approach adopted(4/4)

- Test apparatus
  - **Transparent window**
  - **Grid**
  - **Primer**
  - **(above)before firing**
  - **(below) after firing**

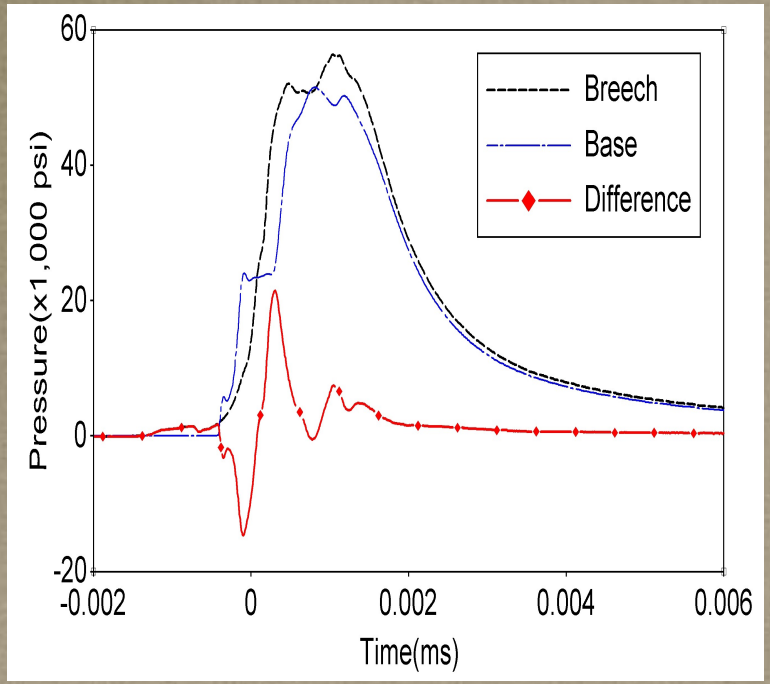
Results achieved(2/4)

- Pressure history
  - **Button-type primer**
  - **P_{max} = 56,000psi**
  - **-ΔP = 15,000psi**
  - **Gage locations**
    -breech: @90mm
    -base: @280mm
  - **Multi peaks**

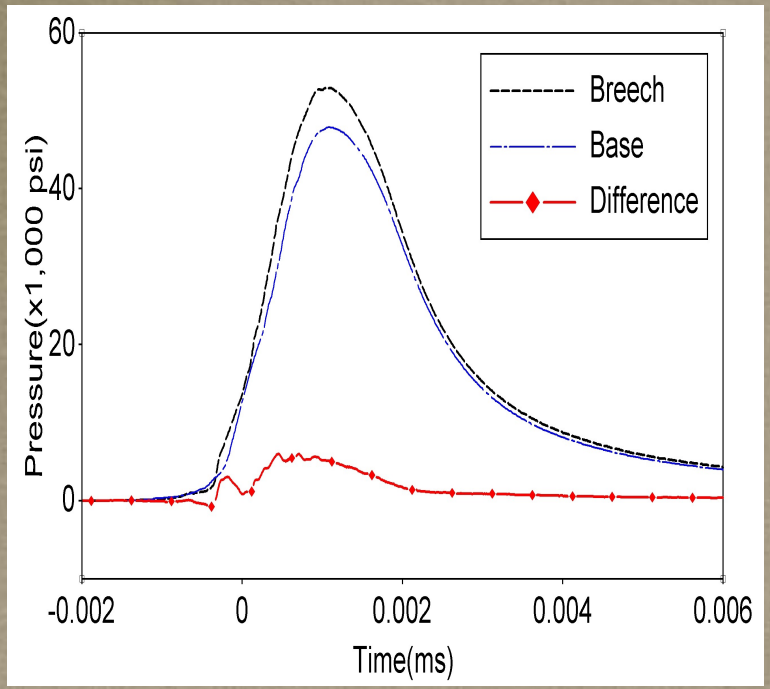
Results achieved(3/4)

- Pressure history
  - **Piccolo-type primer**
  - **P_{max} = 55,000psi**
  - **-ΔP = 2,000psi**
  - **Gage locations**
    -breech: @90mm
    -base: @280mm
  - **Mono peak**

- Finally, when the piccolo-type primer was used in 40mm KE ammunition, the in-bore security problem has been resolved.
  - **No blow back marks in the rear face of the cartridge case**
  - **No multipeaks in pressure history curves**
  - **No NDP in pressure history curves**
